**U.S. ARMY
MISSILE
RESEARCH
AND
DEVELOPMENT
COMMAND**

TECHNICAL REPORT T-79-42

**FINAL EVALUATION OF RAIN EROSION SLED
TEST RESULTS AT MACH 3.7 TO 5.0 FOR SLIP-
CAST FUSED SILICA RADOME STRUCTURES**

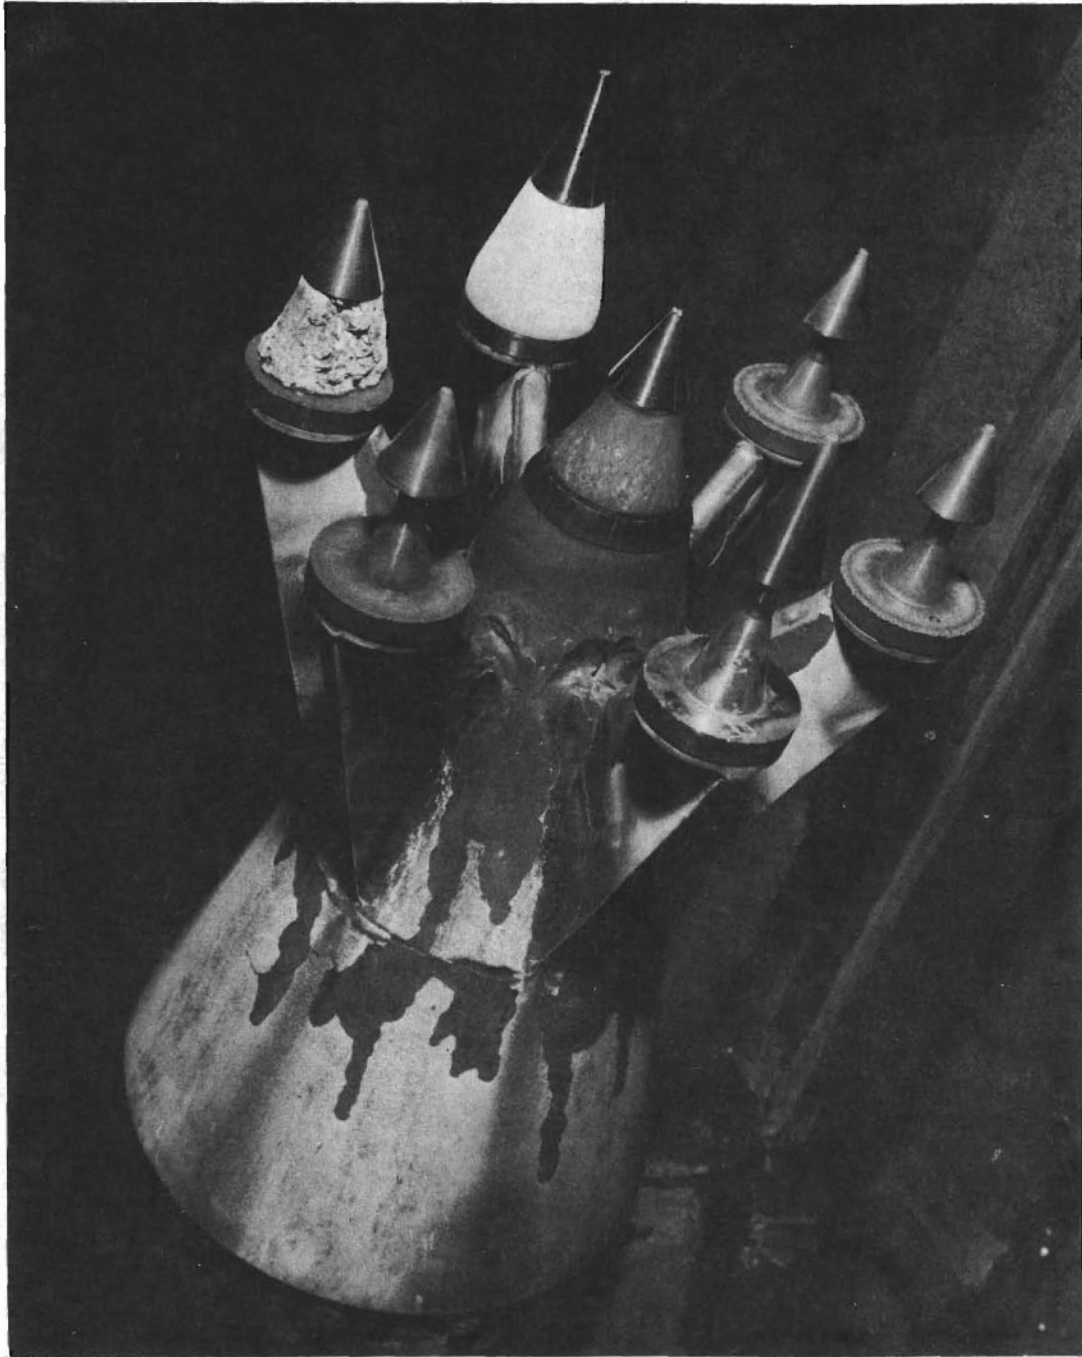
Figure 9. Test vehicle and samples after test 3.

In test 3 only one SCFS model (15 deg in *Figure 9*) survived at Mach 5 through 853 m of artificial rain. The other 15 deg sample was lost after exit from the rainfield. All 22.5 deg models were lost. A ruptured water line, which possibly sprayed water across the track, may have contributed to sample failures in this test. The center sample was Avcoat 8027.
